# The Rehabilitation of the Armco Pipe Arch Culvert on the P14-1 at Kilometre 5.2

## FINALIST – Technical Excellence Category

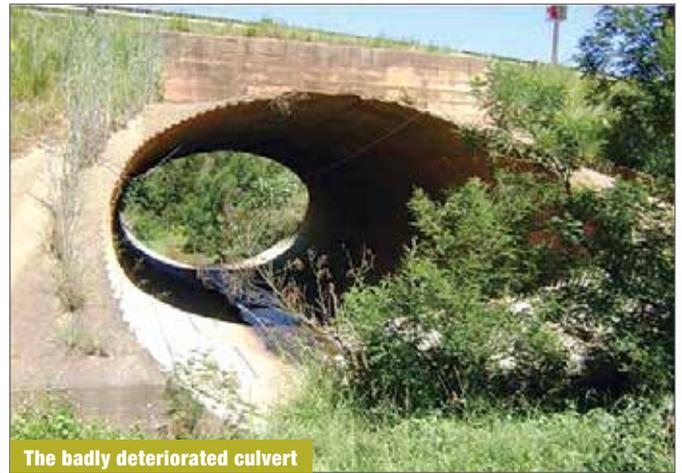
The culvert has a 6 m span, 3.6 m rise and 32 m length, with approximately 4 m of fill above. The invert was so severely corroded that it was no longer able to resist the full lateral earth pressures, and buckled in cross-sections for the full length of the culvert.

The structure's roof had also significantly distorted and was becoming noticeably bigger in the period between the monthly inspections. Structural failure was imminent, with the gradual failure being felt in the depression of the pavement caused by the continuing settlement of the fill above.

The badly deteriorated culvert

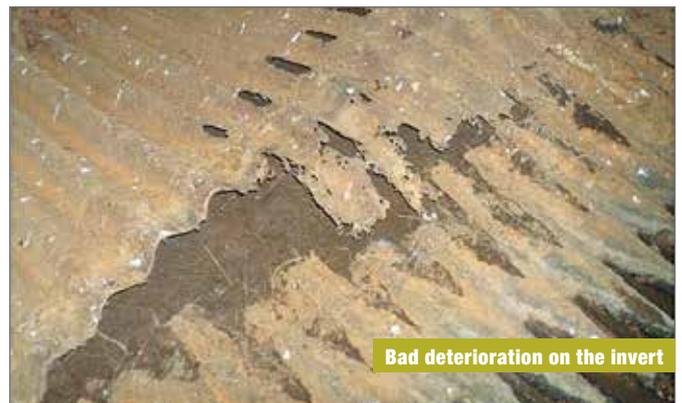
Bad deterioration on the invert

This was of deep concern as heavy agricultural, timber hauling and construction vehicles regularly travel the road, and the culvert relies on its invert to resist the heavy lateral forces. In that state the highly corroded invert could buckle at any time.

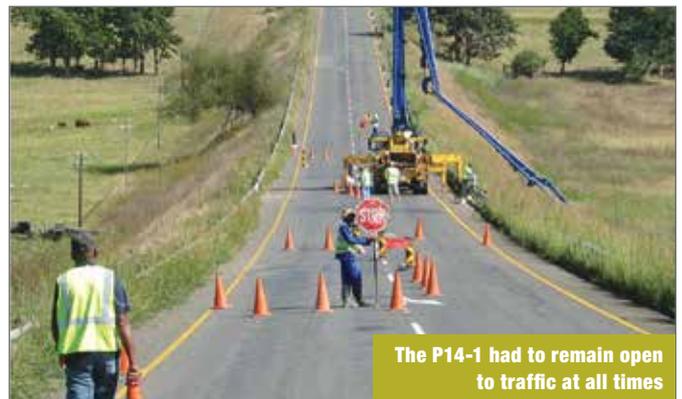
The P14-1 had to remain open to traffic at all times

A traffic management plan, including a “stop and go” system, was therefore enforced to regulate the frequency and speed of vehicles, thereby ensuring safe working conditions in the culvert. Construction work was halted during peak traffic hours.

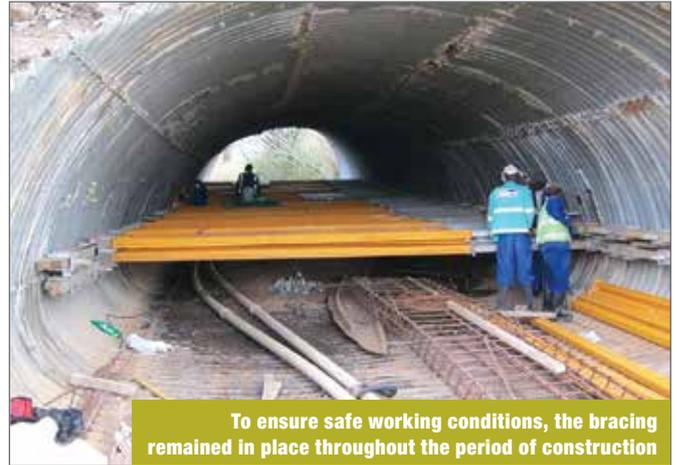
To ensure safe working conditions, the bracing remained in place throughout the period of construction

This high-risk culvert was therefore flagged for emergency rehabilitation or replacement. As a safety precaution, horizontal bracing was introduced to prevent the culvert from buckling any further. This bracing was maintained for the full duration of the design and construction periods.

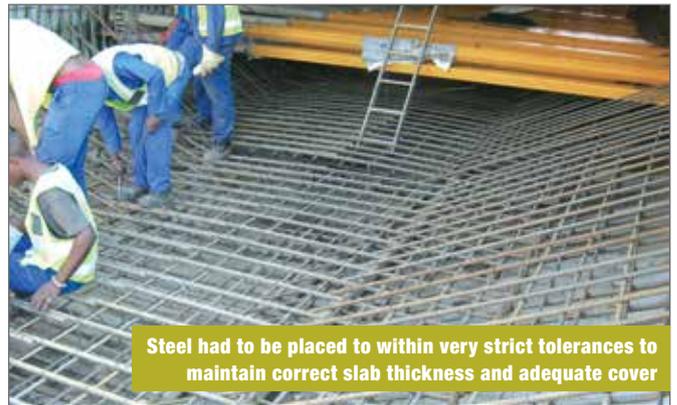
Upon commencement of the works it was soon realised that construction of the new invert, walls and roof slab was going to be a challenge given the culvert’s shape and existing distortions. At the start, there was difficulty in placing steel to very strict tolerances to ensure that critical sections of the culvert maintained correct slab thickness and adequate cover.

Steel had to be placed to within very strict tolerances to maintain correct slab thickness and adequate cover
