The Rehabilitation of the Armco Pipe Arch Culvert on the P14-1 at Kilometre 5.2

FINALIST – Technical Excellence Category

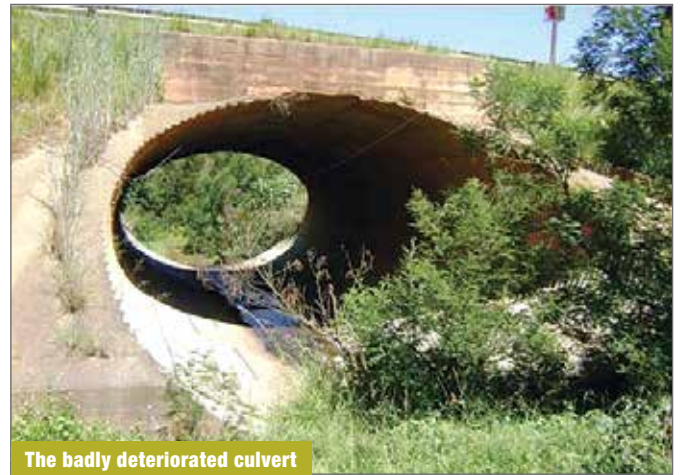
The culvert has a 6 m span, 3.6 m rise and 32 m length, with approximately 4 m of fill above. The invert was so severely corroded that it was no longer able to resist the full lateral earth pressures, and buckled in cross-sections for the full length of the culvert.

The structure's roof had also significantly distorted and was becoming noticeably bigger in the period between the monthly inspections. Structural failure was imminent, with the gradual failure being felt in the depression of the pavement caused by the continuing settlement of the fill above.

The badly deteriorated culvert

This high-risk culvert was therefore flagged for emergency rehabilitation or replacement. As a safety precaution, horizontal bracing was introduced to prevent the culvert from buckling any further. This bracing was maintained for the full duration of the design and construction periods.

Due to site and cost constraints it was decided to construct a reinforced concrete structure within to resist all loads on the existing culvert. Construction could then occur without removing the existing culvert. This option offered the required flexibility to work with the distorted culvert which could maintain the cross-section hydraulic requirements and have minimum impact on the overhead traffic.

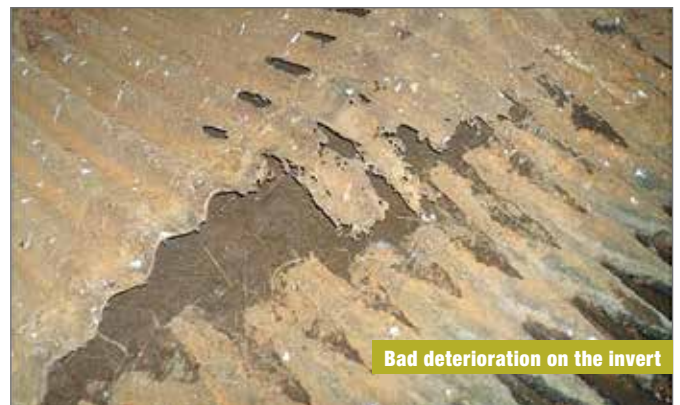
Bad deterioration on the invert

This was of deep concern as heavy agricultural, timber hauling and construction vehicles regularly travel the road, and the culvert relies on its invert to resist the heavy lateral forces. In that state the highly corroded invert could buckle at any time.

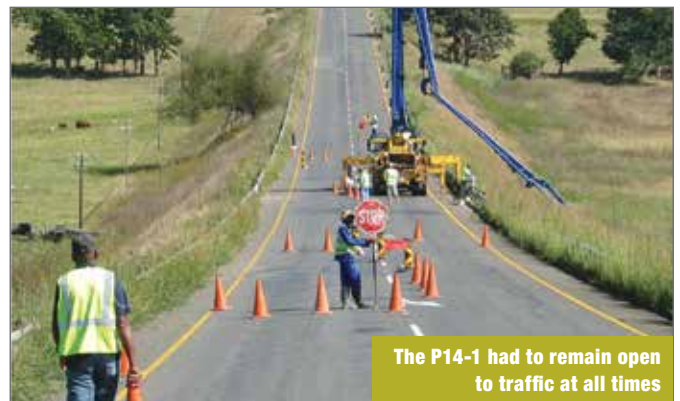
The P14-1 had to remain open to traffic at all times

The P14-1 had to remain open to traffic at all times as there was no alternative access routes to service the adjacent farm properties. A detour was investigated, but, due to the high fill embankments and the associated steep costs, it was not feasible.

A traffic management plan, including a “stop and go” system, was therefore enforced to regulate the frequency and speed of vehicles, thereby ensuring safe working conditions in the culvert. Construction work was halted during peak traffic hours.

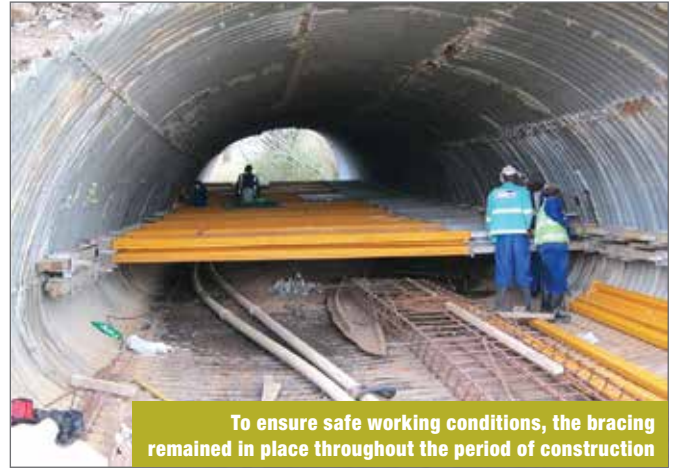
To ensure safe working conditions, the bracing remained in place throughout the period of construction

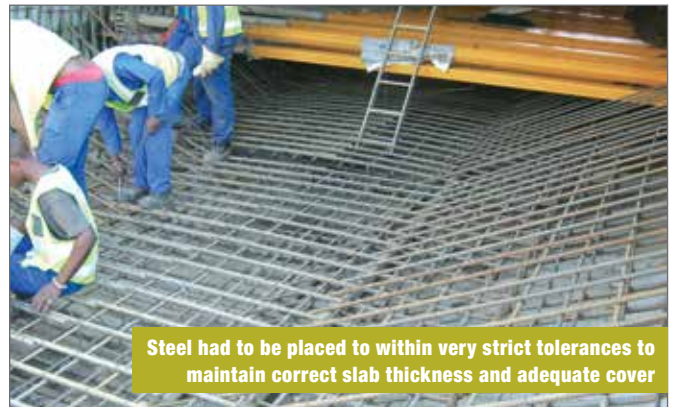
Upon commencement of the works it was soon realised that construction of the new invert, walls and roof slab was going to be a challenge given the culvert’s shape and existing distortions. At the start, there was difficulty in placing steel to very strict tolerances to ensure that critical sections of the culvert maintained correct slab thickness and adequate cover.

Steel had to be placed to within very strict tolerances to maintain correct slab thickness and adequate cover
