Emergency Repairs to Sani Pass

FINALIST Technical Excellence Category

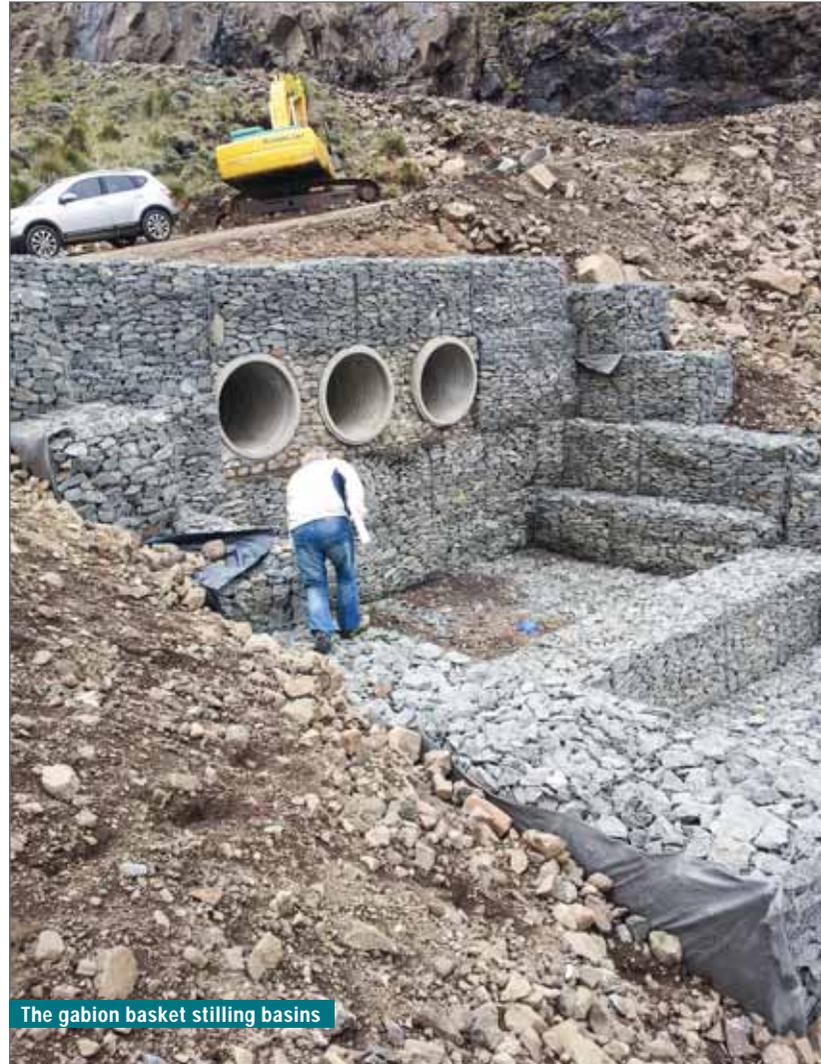
The gabion basket stilling basins

It was a design requirement to discharge the stormwater directly onto bedrock or into multiple stilling basins so as to prevent the erosion of the *in situ* talus material. The multiple stilling basins reduced the velocity of the stormwater, preventing future erosion and scouring.

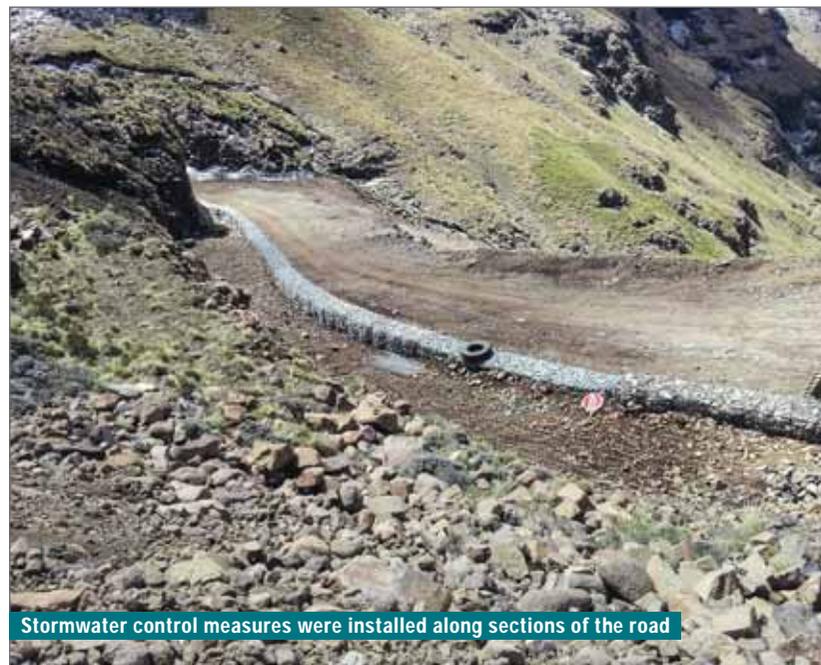
Stormwater control measures were installed along sections of the road

The design allowed the diversion of stormwater into the natural drainage gullies on the right-hand side of the pass by using stormwater pipe culverts and gabion basket barrier walls. It was also necessary to bed the pipe culverts and gabion basket barrier wall on the existing bedrock. This required trench blasting for both the pipe culverts and gabion basket barrier walls.
