Temporary structure
to restore service

Brakspruit Bridge Project

SUMMARY

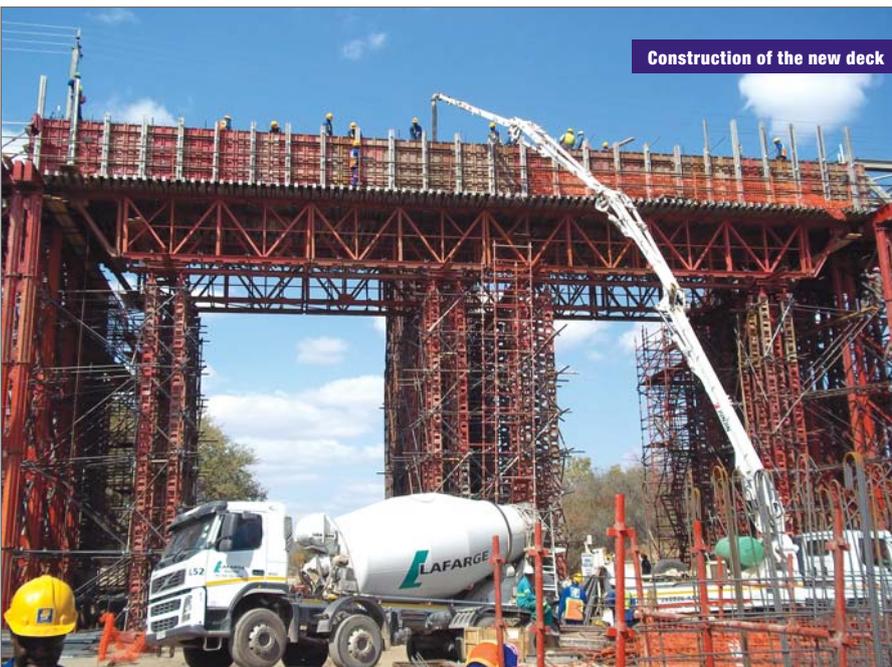
Construction of the new deck

In section the deck was 6 m wide and comprised 2.2 m deep edge beams connected by a 0.3 m thick slab. The deck was designed as simply-supported for the three spans, with link slabs over the piers to eliminate the need for expansion joints. Due to the limitations of concrete supply the deck was cast in three stages. After the concrete had attained a strength of 35 MPa each span of the deck was prestressed with 108 strands to a force of 21 MN.

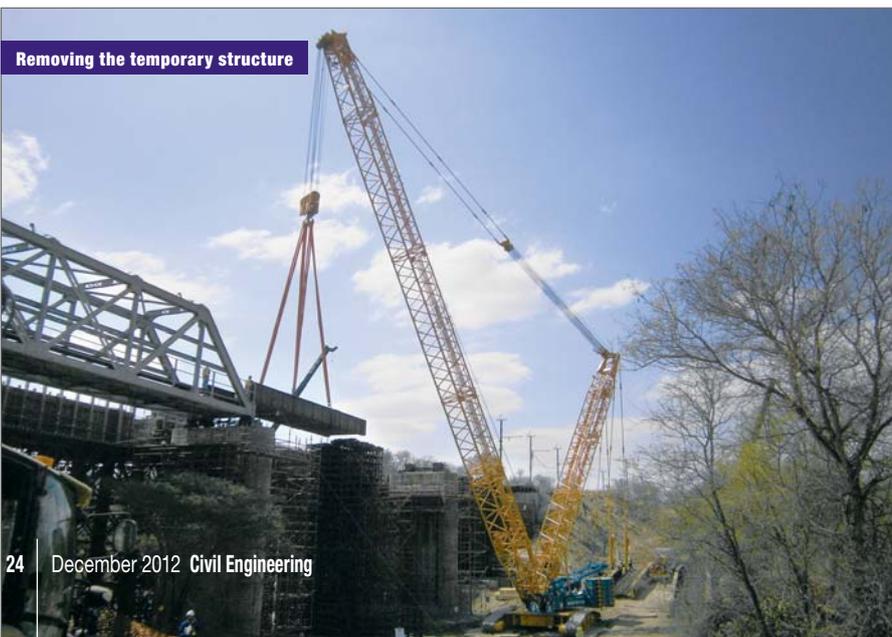
Removing the temporary structure

At the start of the occupation period the rail infrastructure was removed from the temporary bridge before the plate girders and cribs were dismantled. The single remaining span of the original truss bridge was also removed. This required the establishment of a 650 t crawler crane which was the largest single cost to the project. Once the temporary structure

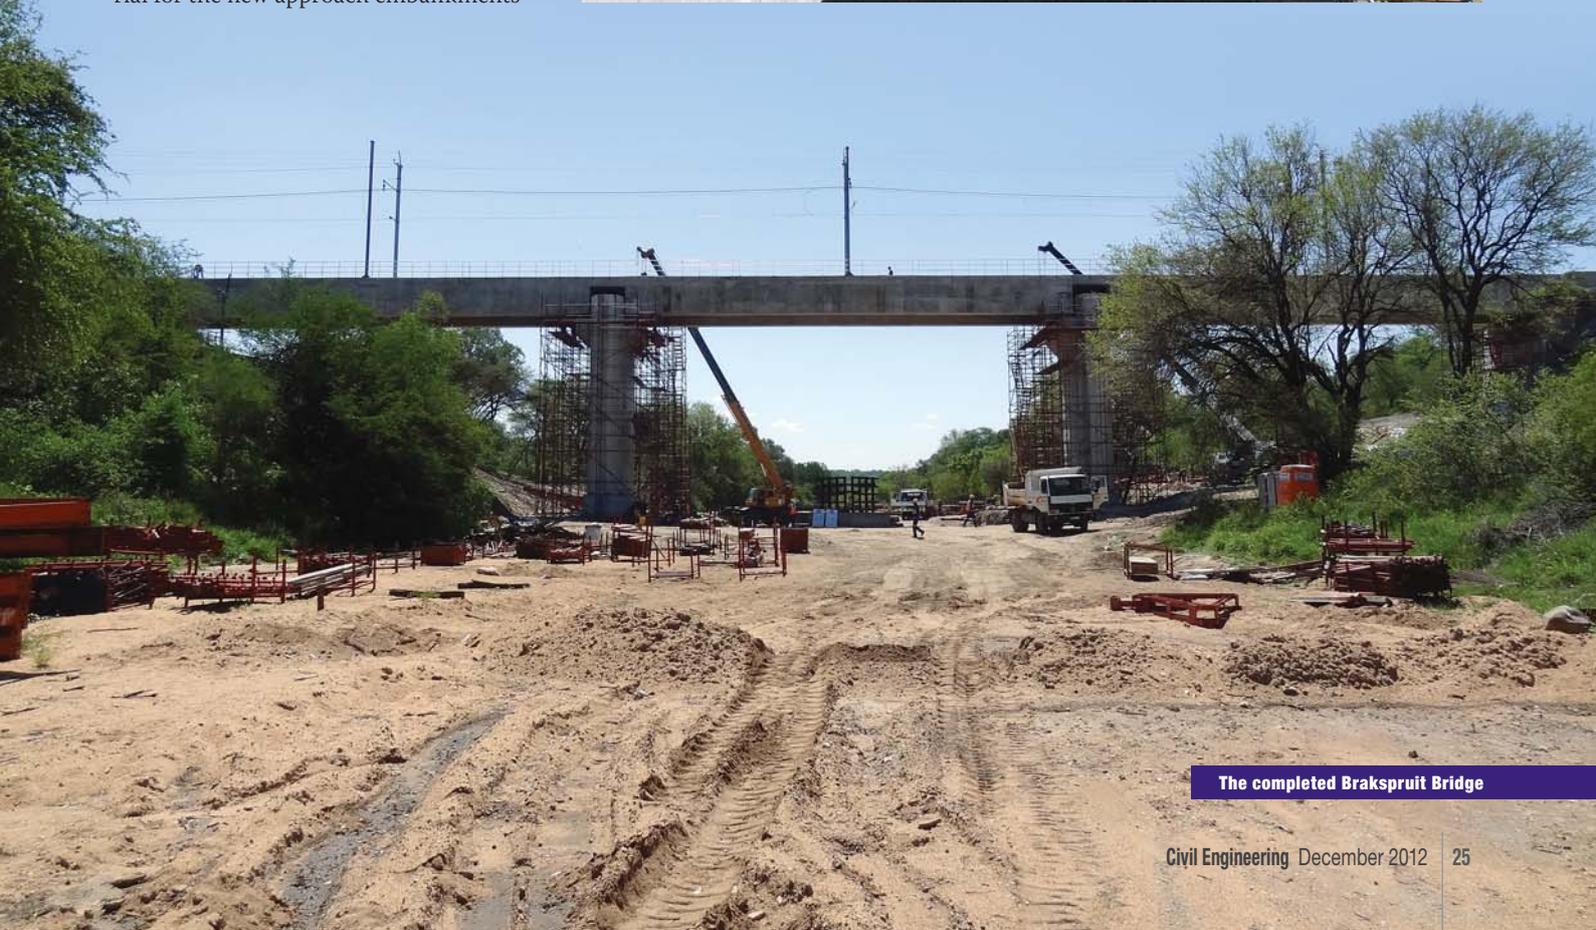
The completed Brakspruit Bridge

had been removed the new deck could be moved into position. The deck was supported on elastomeric bearing pads with a PTFE sliding surface which slid over the polished steel plate. The entire 100 m long and 6 m wide deck weighing nearly 1 700 tons, was moved by synchronising six 95 t hollow plunger cylinder jacks which pulled on 36 mm diameter high-strength steel bars. The maximum force required to move the bridge was 135 tons. After the deck had been moved into position, it was raised slightly to remove the slide beams and install the permanent pot bearings. The ballast, sleepers, track and electrical infrastructure were installed by TFR as soon as the deck was in place.
