Temporary structure
to restore service

Brakspruit Bridge Project

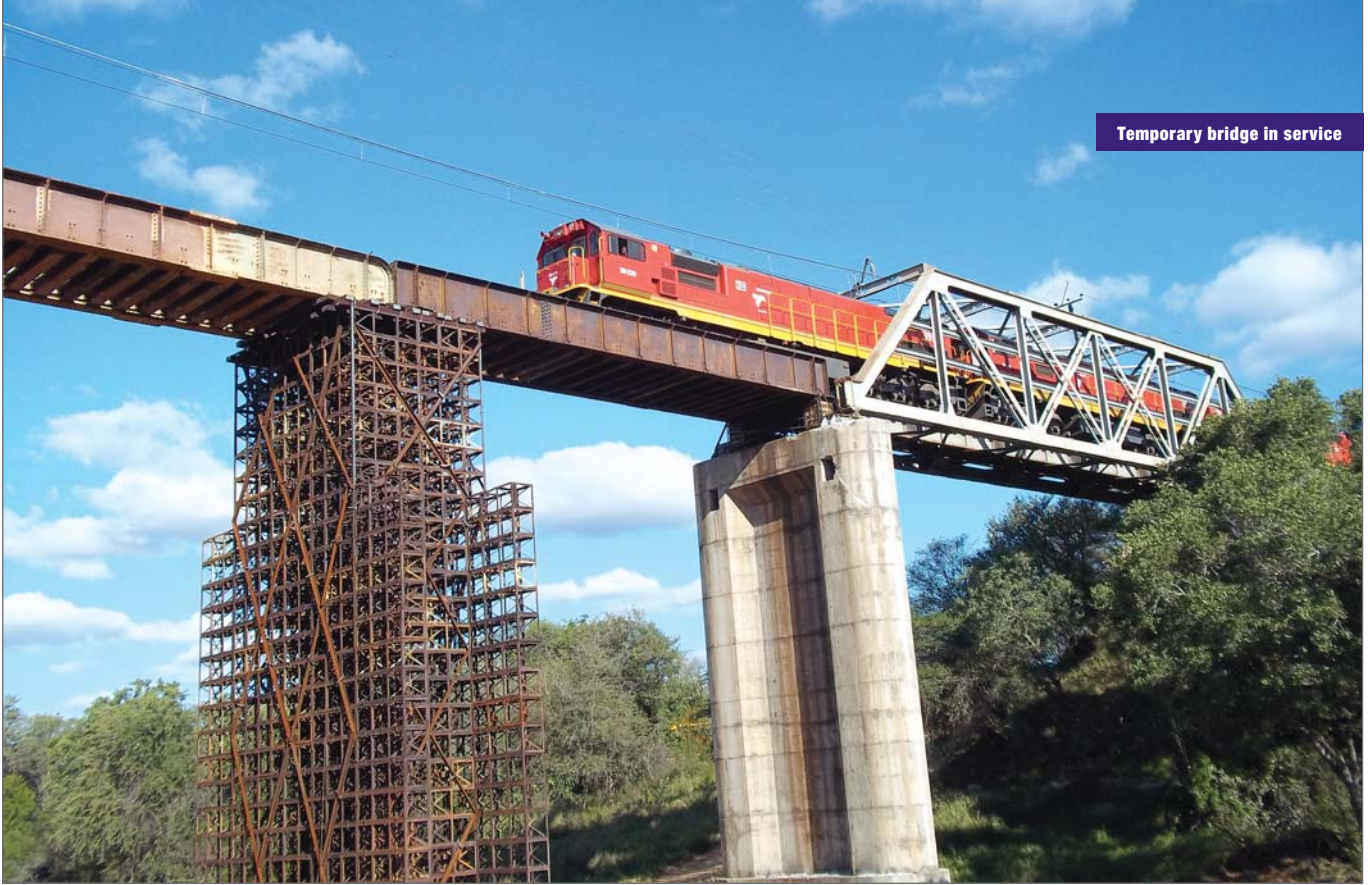
Construction of the new deck

A major part of the work required on site was the temporary work necessary to support the new prestressed concrete deck and to form a slide path onto the strengthened substructure. Temporary foundations comprised large quantities of soilcrete fill within the river channel, together with the installation of micro piles through boulder formations near the abutments. A system of high-load props and steel girders was preferred to a conventional staging layout, as it was less susceptible to damage from floods. The slide path was formed from a 35 mm thick polished steel plate on top of a pair of large steel beams.

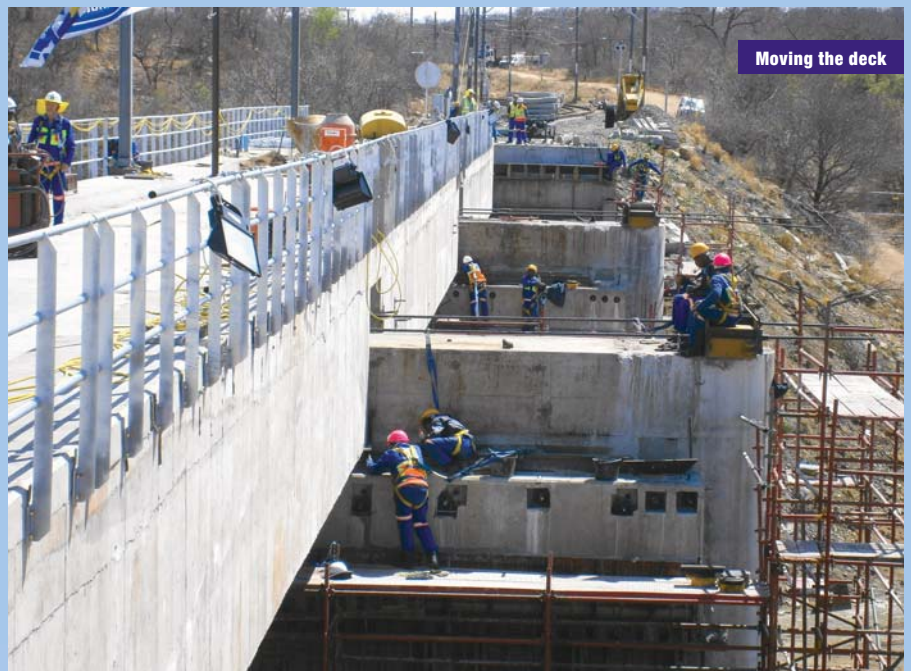
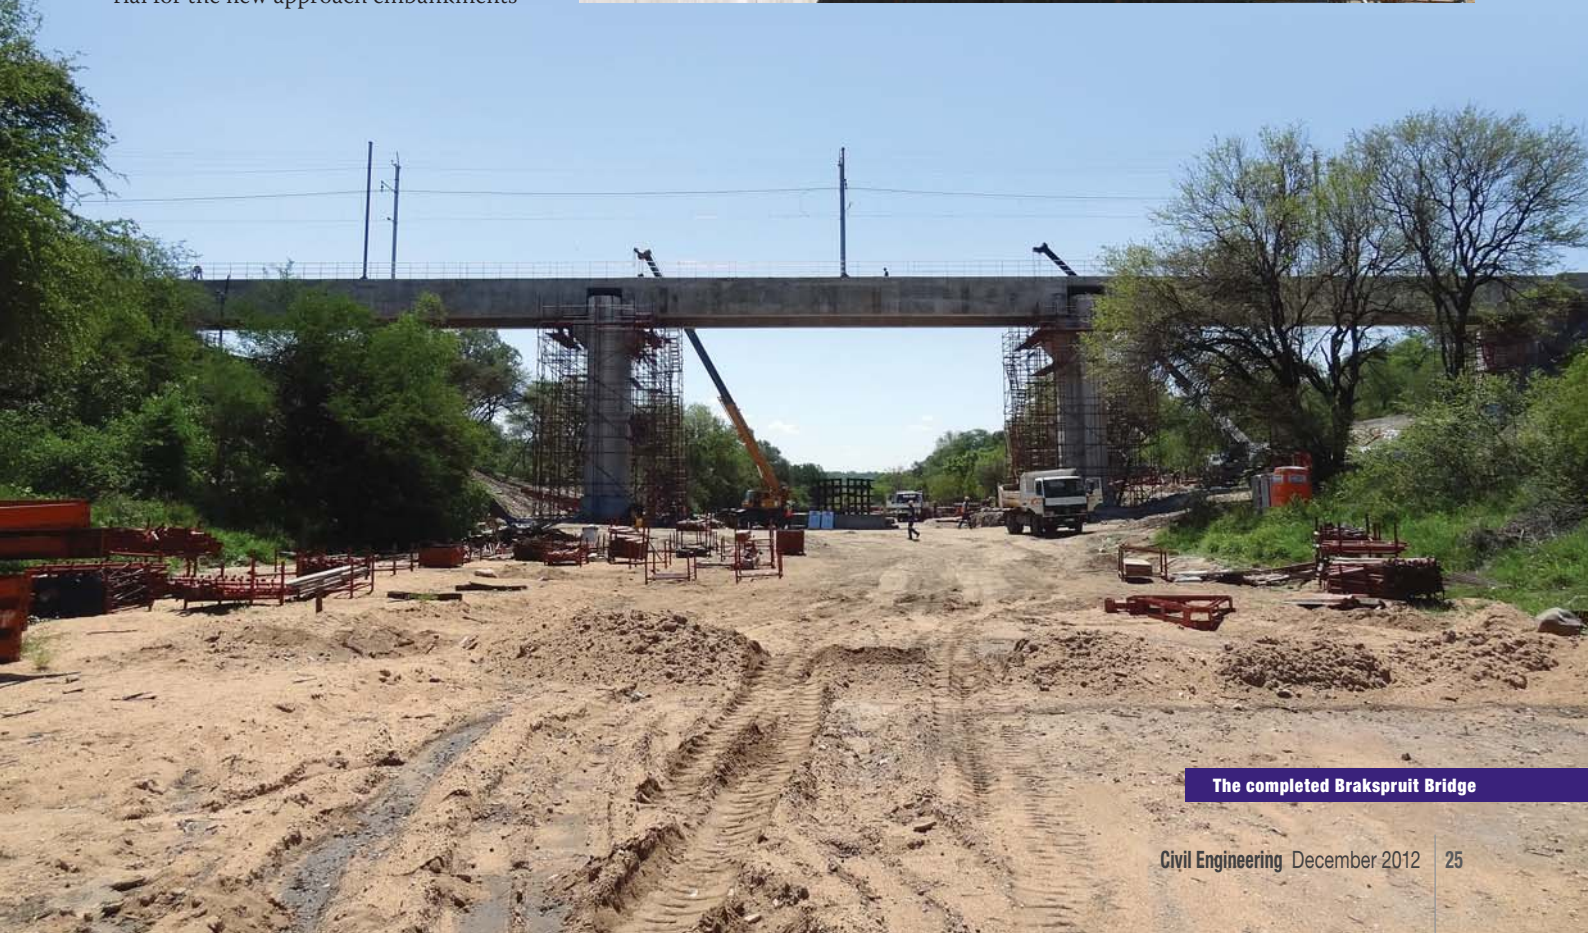
The completed Brakspruit Bridge

had been removed the new deck could be moved into position. The deck was supported on elastomeric bearing pads with a PTFE sliding surface which slid over the polished steel plate. The entire 100 m long and 6 m wide deck weighing nearly 1 700 tons, was moved by synchronising six 95 t hollow plunger cylinder jacks which pulled on 36 mm diameter high-strength steel bars. The maximum force required to move the bridge was 135 tons. After the deck had been moved into position, it was raised slightly to remove the slide beams and install the permanent pot bearings. The ballast, sleepers, track and electrical infrastructure were installed by TFR as soon as the deck was in place.
