Cape Town Stadium structural challenges

CAPE TOWN STADIUM: STRUCTURAL CHALLENGES

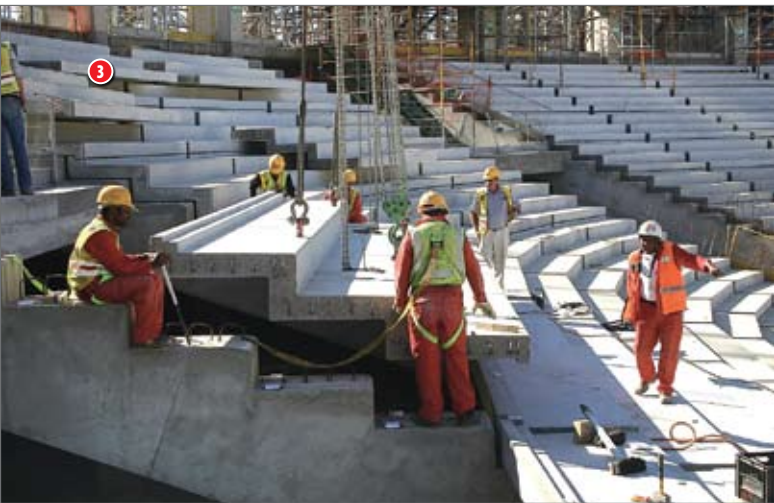
② Inclined pylon construction (Photo: Terry February)

As a direct consequence of these two changes, extensive RC elements were added to cater for in-plane forces in the radial planes, especially under seismic loading. More critical from a programming point of view, the pylons could no longer be constructed freely ahead of the rest of the structure (see photo 2).

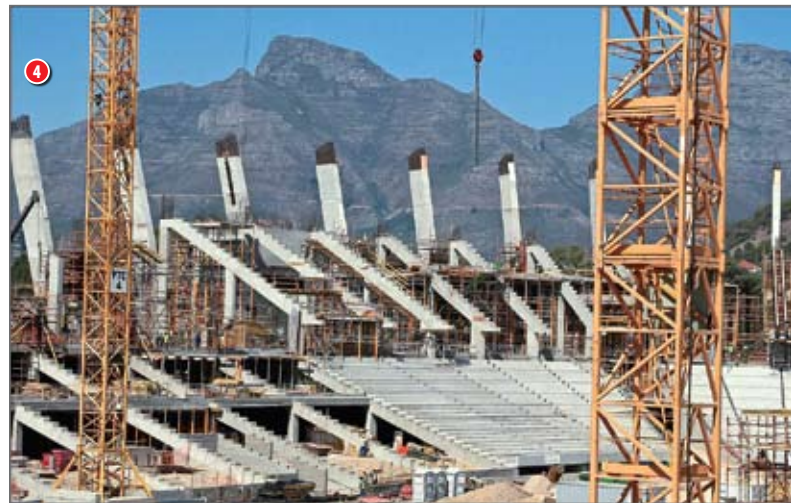
③ Pre-cast seating beam installation (Photo: Gerrit Bastiaanse)

- Finite element analysis was used to check the natural frequencies of the PC seating beams, which as a result were cast in 3-stepped Z-shaped sections, increasing their stiffness (see photo 3).
- Being supported on in-situ concrete raking beams, construction tolerance was built into the plan arrangement by incorporating a 200 mm strip of in-situ concrete between the PC seating panels. This provided moment continuity under live loads and assisted in stiffening the structure, improving both seismic resistance and frequency response (see photo 4).

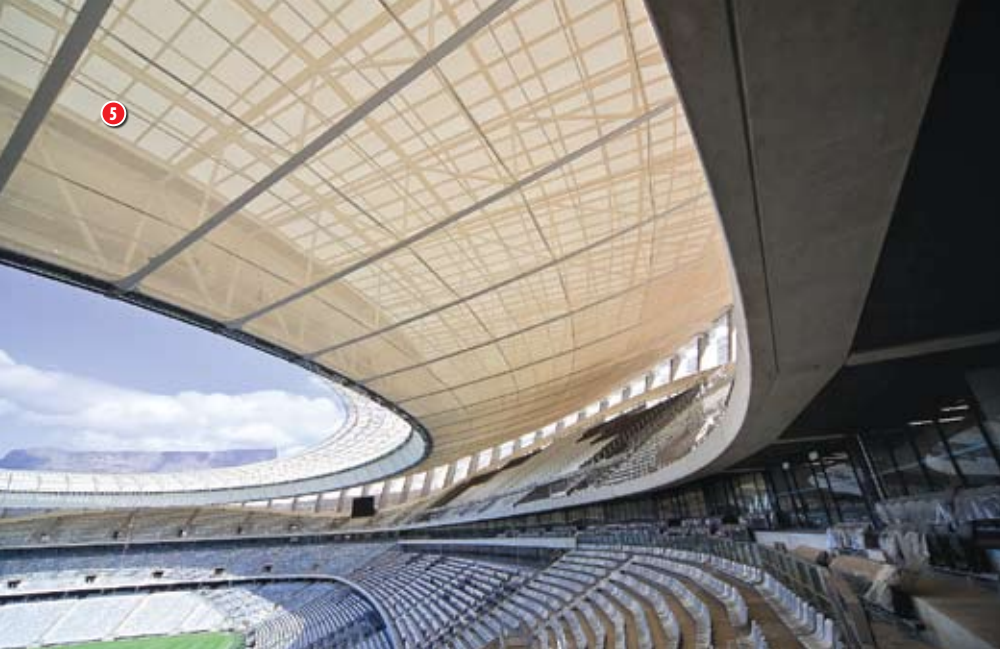
④ Pre-cast seating beams and their supporting raking beams (Photo: Gerrit Bastiaanse)

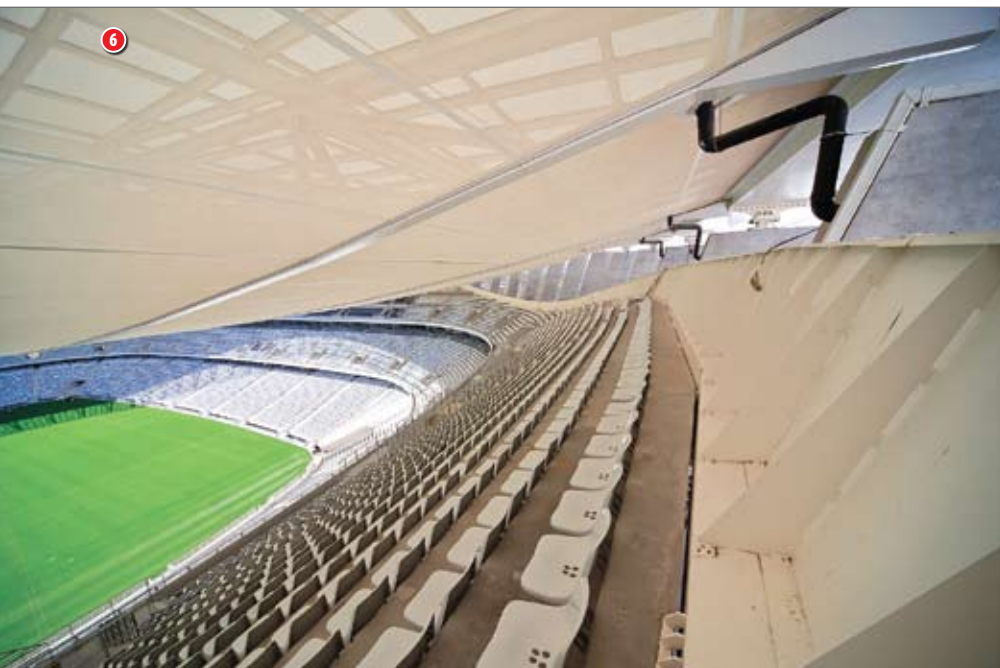
- 5 Tier front edge (Photo: Schalk Marais)
- 6 Steel balustrade beam (Photo: Schalk Marais)
- 7 Perimeter escape stairs (Photo: Terry February)
- 8 Steel and glass roof construction (Photo: Terry February)

- Considerable attention was given to the highly visible front tier edges. Unlike the segmented seat panels, they follow various radii to create the continuous curved front edge. These front edges are not supported directly on the raking beams, but cantilever beyond, providing an elegant edge to the concrete tiers (see photo 5).
