# Rehabilitation of Hanger Street and Harvey Road

## OVERVIEW

Hanger Street and Harvey Road in Bloemfontein's CBD were in desperate need of rehabilitation due to the severe extent of crocodile cracking, deformation, longitudinal and transverse cracking, degraded patches, potholes and undulations.

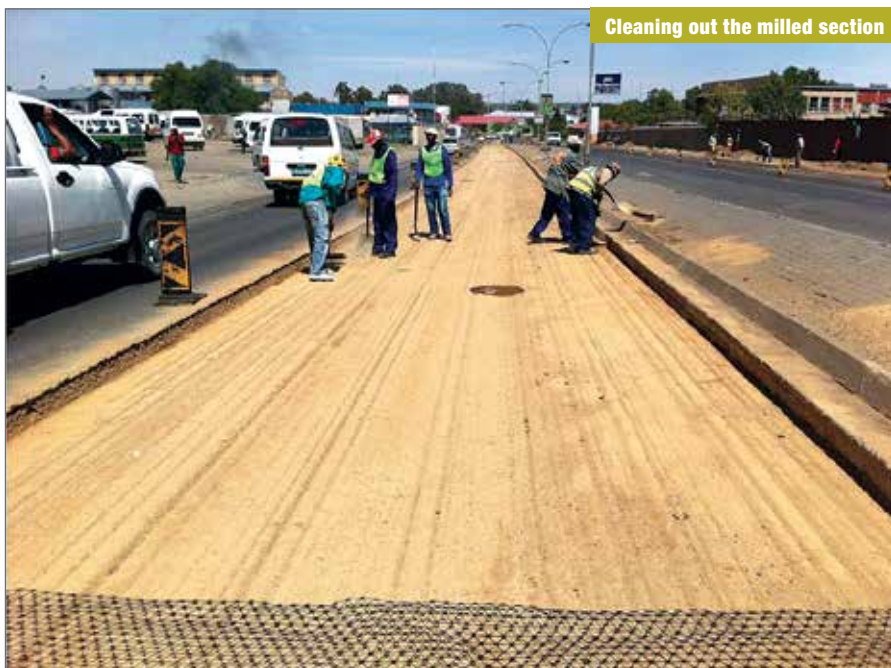
Cleaning out the milled section

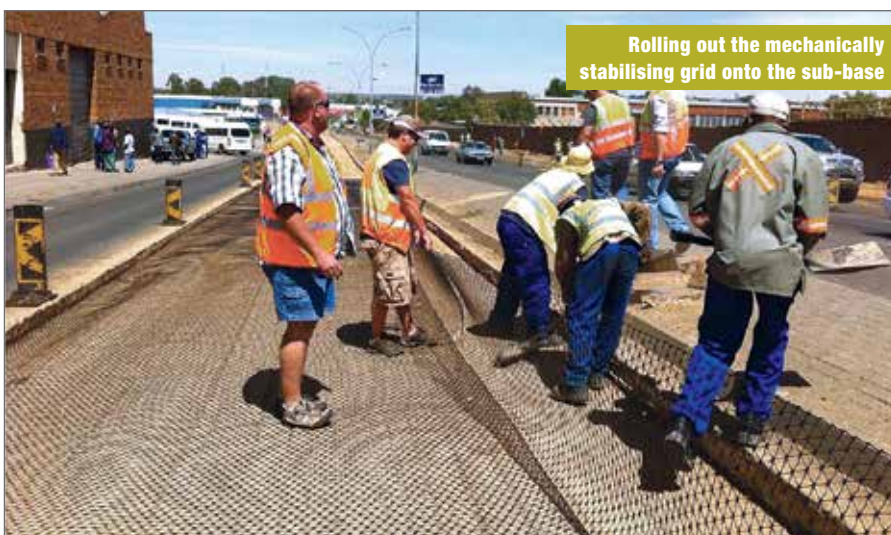
Rolling out the mechanically stabilising grid onto the sub-base

Stabilising grids compensated for the low bearing capacity of the lower layers and served as a stabilising layer. Normal practice would have been to back-tip material onto the stabilising grid and work the material with graders onto the grid without driving on top of it, which in this case was not possible. Therefore, the only material suitable to carry the design traffic would be bitumen-stabilised crushed stone on top of the stabilising grid. These two technologies used in isolation are not new, but the combination of the two is.

- The mechanical stabilising grid compensated for the low bearing capacity of the lower layers and had the advantage of reducing the layer depth needed on top. It also saved on replacing the lower layers.

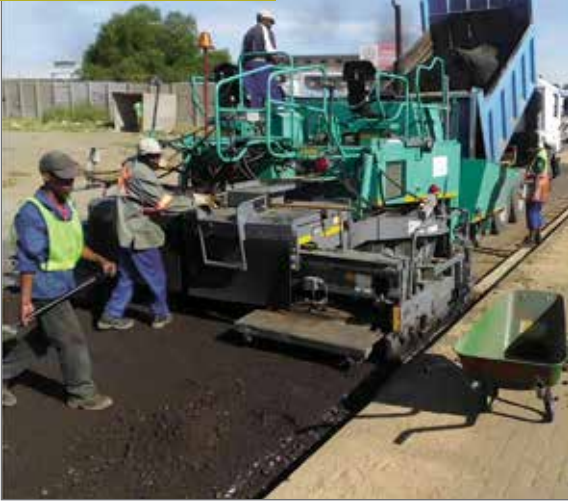
Asphalt paver working on top of the stabilising grid

The bitumen-stabilised crushed stone was paved with an asphalt paver on top of the grid, but a normal asphalt paver with wheels was also able to drive on the grid without damaging it – the correct roller combination ensured a smooth finish and a dense layer.
