Nelson Mandela Multi-Purpose Stadium

NELSON MANDELA MULTI-PURPOSE STADIUM

Technical Excellence category

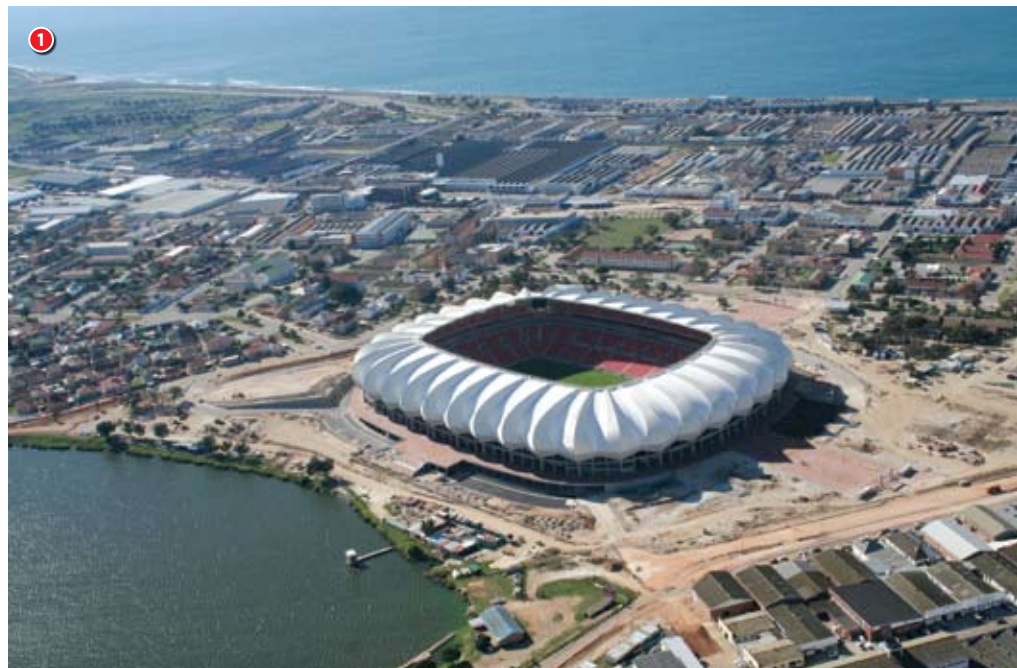
1 The Nelson Mandela Multi-Purpose Stadium is located about 50 m from Port Elizabeth's North End Lake, and within 1 km from the sea

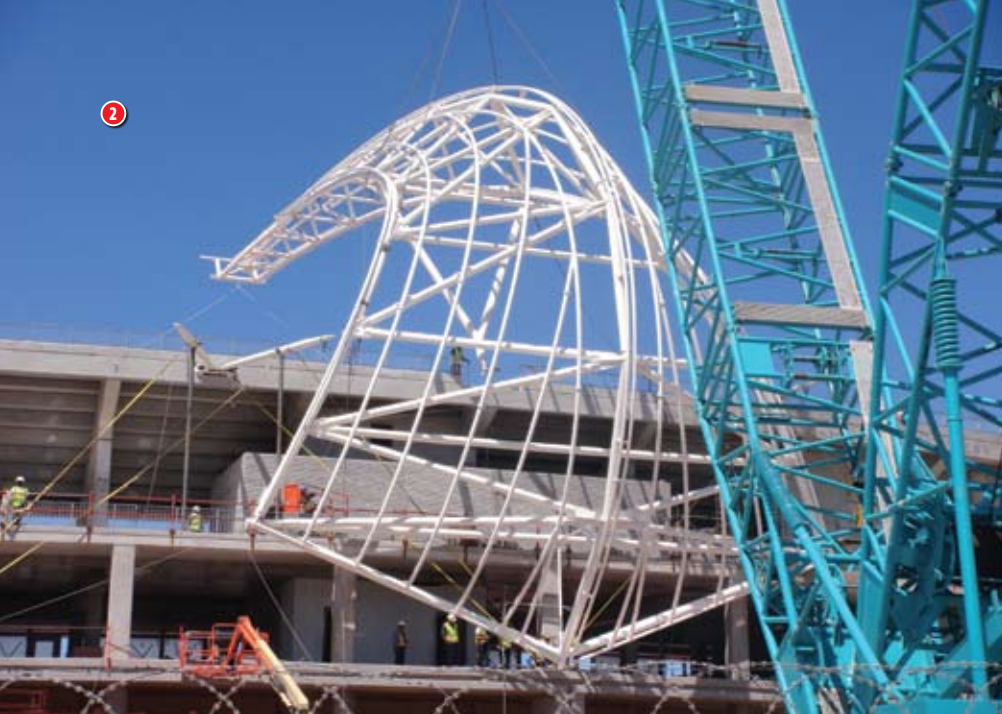
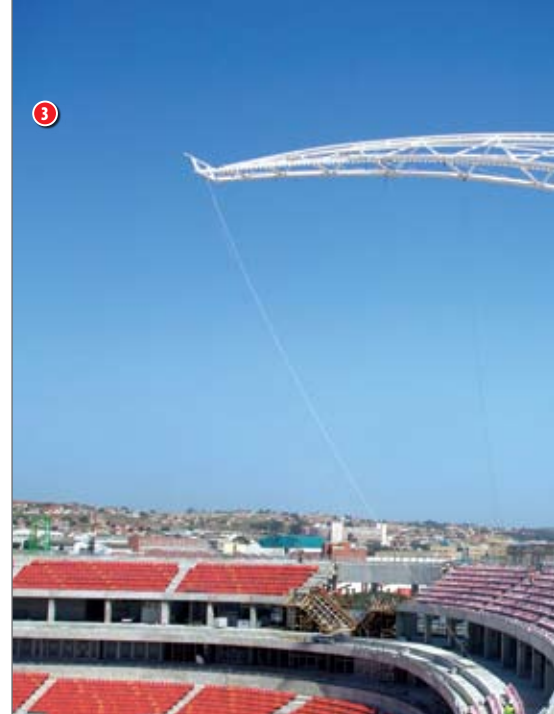
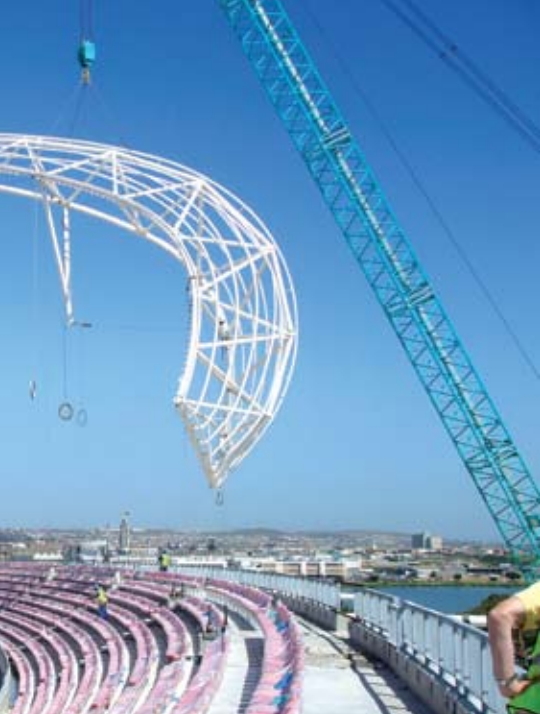
2 and 3 and 4 The roof girders were installed entirely from the outside of the stadium. The window of operation for the 500 t caterpillar crane was limited by the notorious Port Elizabeth winds, resulting in the erection of the girders occurring mostly in the morning

In order to not interfere with the work on and around the playing field, the pre-fabricated girders had to be installed entirely from the outside of the stadium. The pre-fabrication of the girders was performed on scaffolding, which was equipped with individually adjustable clamping saddles to accommodate the different girder geometries. After the calibration of the scaffolding, mobile cranes lifted the pre-fabricated units into place, where they were bolted. The tip of the girder was set in place as a single unit at the end. To compensate for the tolerances from fabrication and the bolt-hole clearance of the connections, the girder tips were initially set in the specified

The window of operation for the 500 t caterpillar crane was limited by the maximum wind speed of 10 m/s. As such wind speeds occur daily in Port Elizabeth, often already before noon, the erection of the girders occurred mostly in the early hours of the morning. The installation of the aluminum cladding proved equally challenging in these windy conditions.

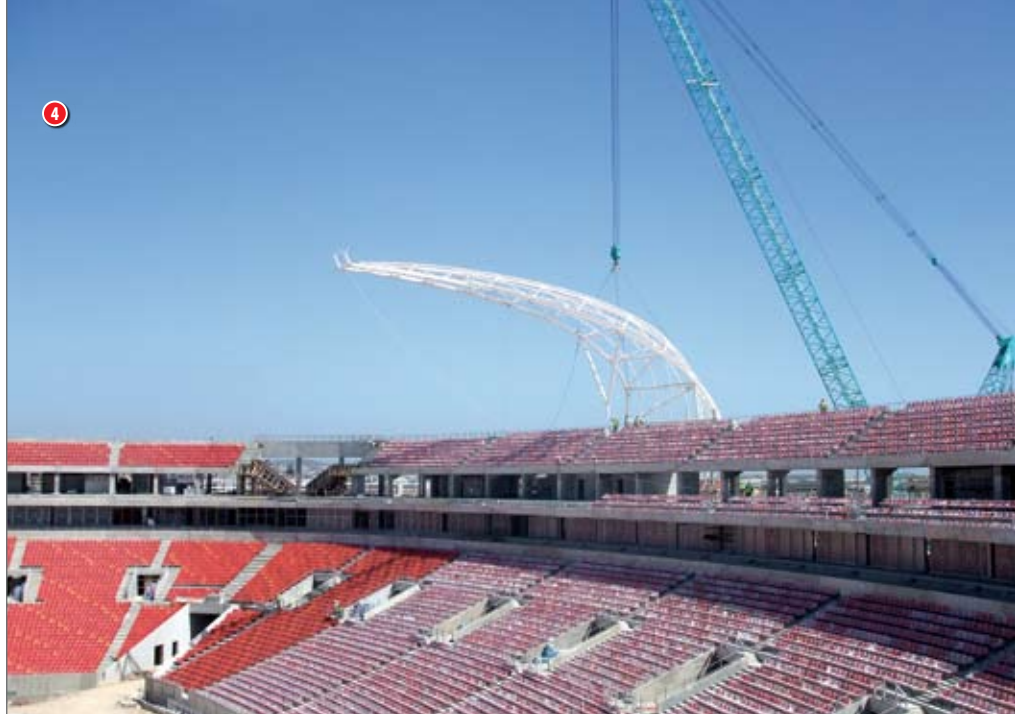
5 The initial programming sequence required the roof to be erected in a clockwise direction only, but it became necessary to change this sequencing to 30% clockwise and 70% anti-clockwise, resulting in a time-saving of several months

The roof erection process started on the north stand, progressing clockwise until the west stand concrete works had been sufficiently completed to allow the erection of the roof there. Once the roof, including its coverings, had been erected on the west stand, the finishings in that area became the critical element, together with the external works which could not be started until the roof erection crane had been relocated to another area. The initial programming sequence required the roof to be erected in a clockwise direction only, but it became necessary to change this sequencing to 30% clockwise and 70% anti-clockwise, resulting in a time-saving of several months.

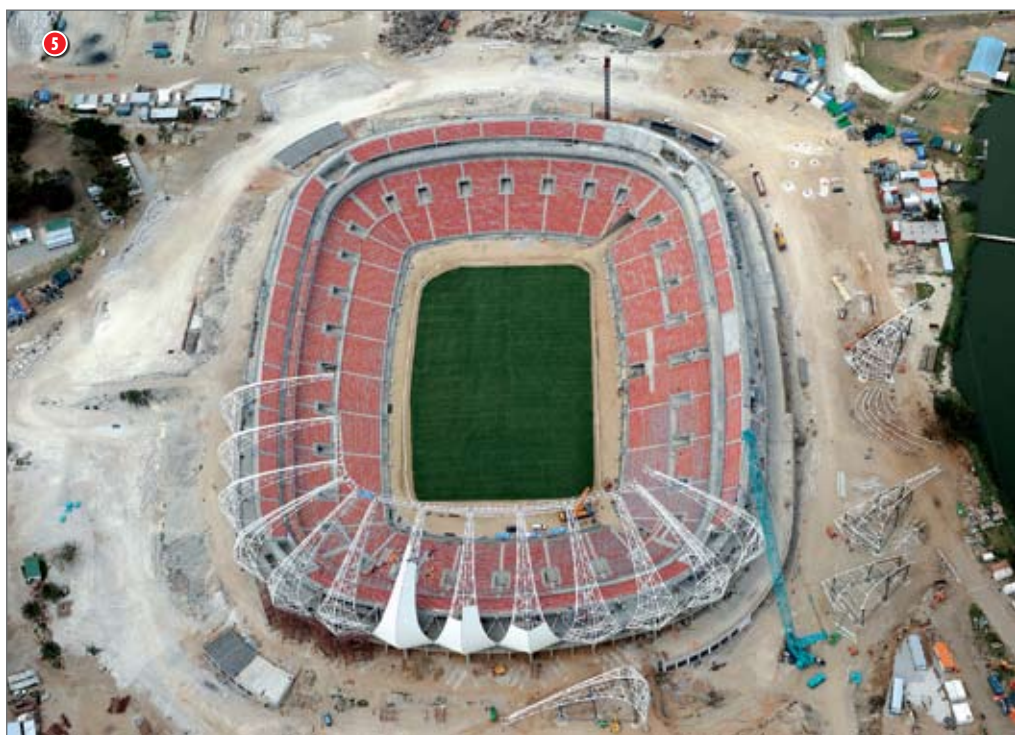
6 The roof acquires its remarkable form from the alternating arrangement of the girders and the membrane surfaces spanned in-between

The roof cladding terminates before the façade to provide a wind-tight connection of the roof to the façade, without requiring additional provisions. The roof acquires its remarkable form from the alternating arrangement of the girders and the membrane surfaces spanned in-between.

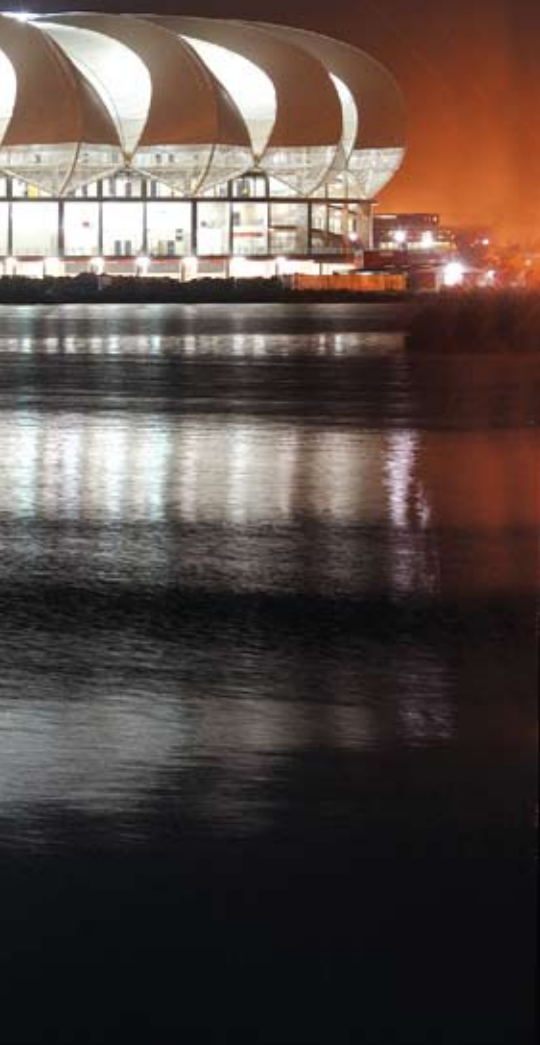
7 The backlit membrane surfaces of the roof make the stadium widely visible at night
