Storms River Mouth new foot bridges

STORMS RIVER MOUTH – NEW FOOT BRIDGES

Technical Excellence category

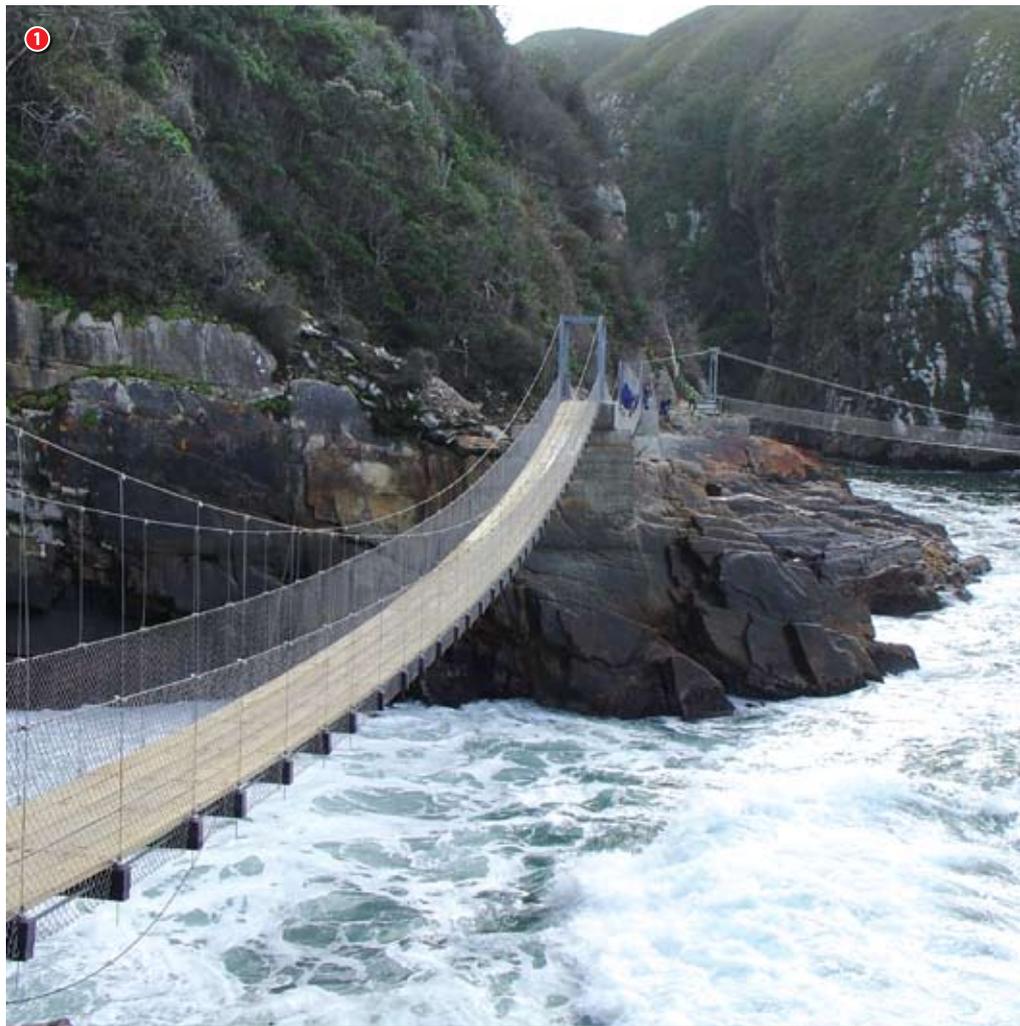
- 1 Safe above the waves – newly constructed pedestrian suspension bridges at Storms River Mouth

These constraints led to the selection of a suspension bridge supported on cables anchored to modular galvanised steel structures with polywood walking surfaces and stainless steel fittings used wherever possible.

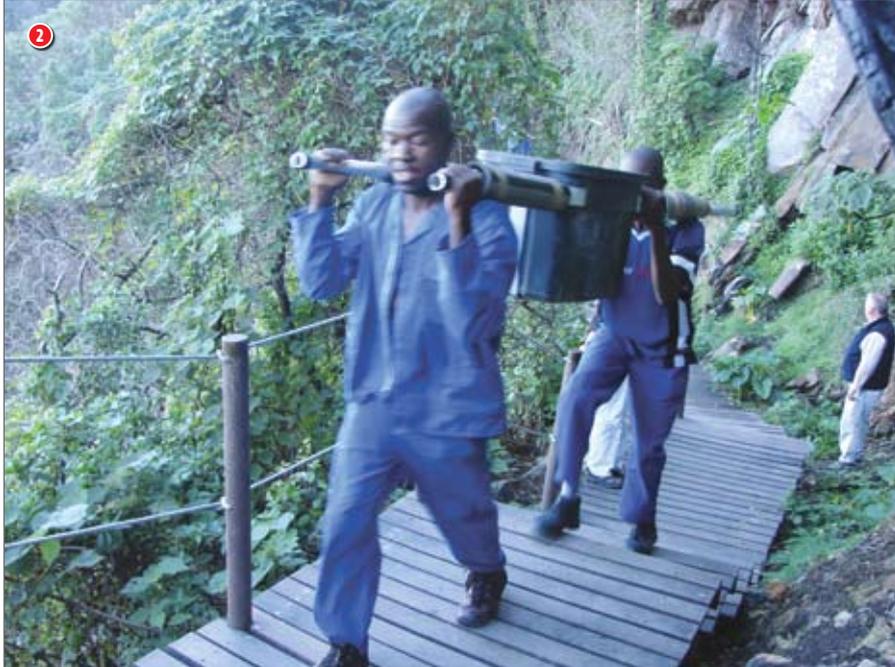
- ② All materials and support works were carried in by hand
- ③ Not the easiest site conditions – centre pier under construction

All materials and support works were carried in by hand along a 1 km winding boardwalk, which was steep in places with steps, and which was also still being used by tourists.

In order to bring in the materials, the contractor manufactured unique carrying containers, not unlike an old-style sedan chair, which could be carried by two people, safely and with health and safety criteria in mind. The heavy suspension cables were unwound from their drums and carried in by a long team of labourers in 'snake' fashion.
