# Storms River Mouth new foot bridges

Constructing pedestrian suspension bridges, while coping with heavy seas and high tides in an environmentally sensitive area that is virtually inaccessible for normal modes of construction, is what this unique project was all about

## STORMS RIVER MOUTH – NEW FOOT BRIDGES

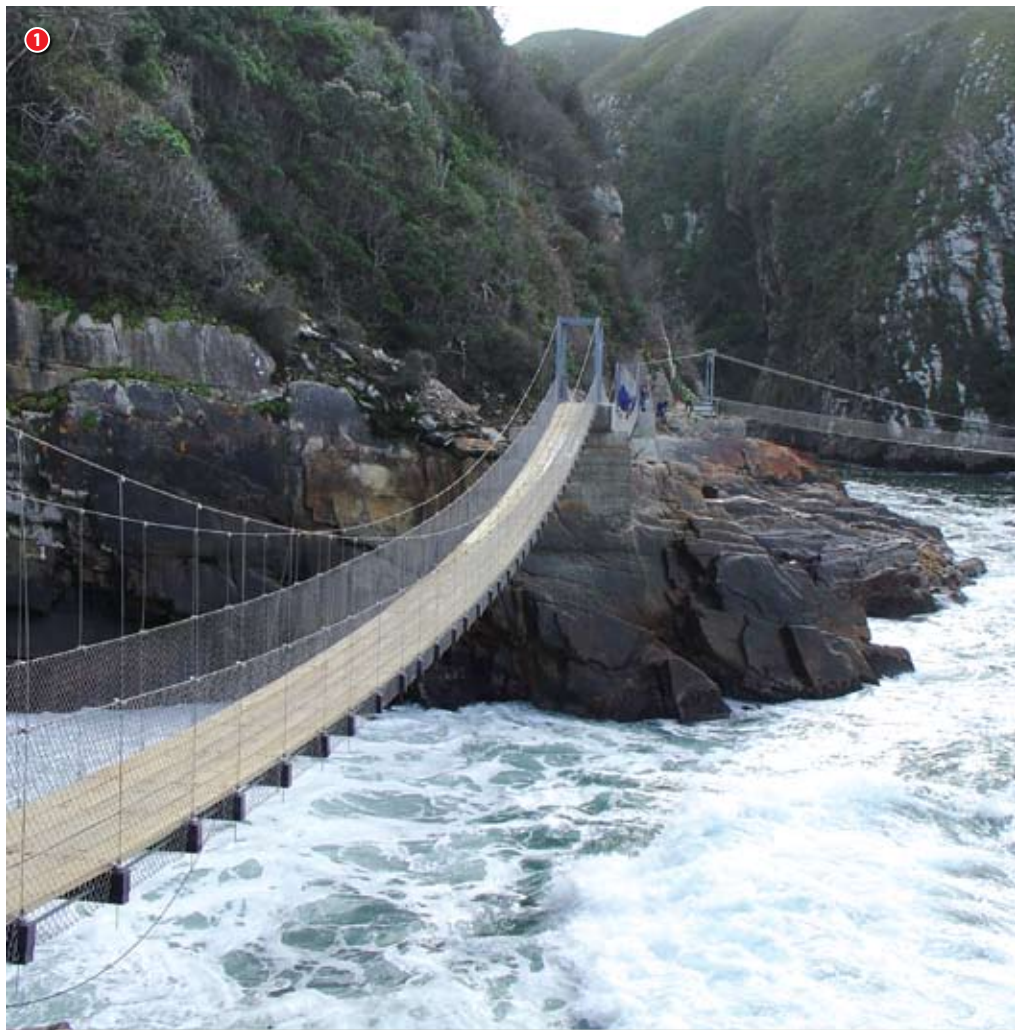
- 1 Safe above the waves – newly constructed pedestrian suspension bridges at Storms River Mouth

These constraints led to the selection of a suspension bridge supported on cables anchored to modular galvanised steel structures with polywood walking surfaces and stainless steel fittings used wherever possible.

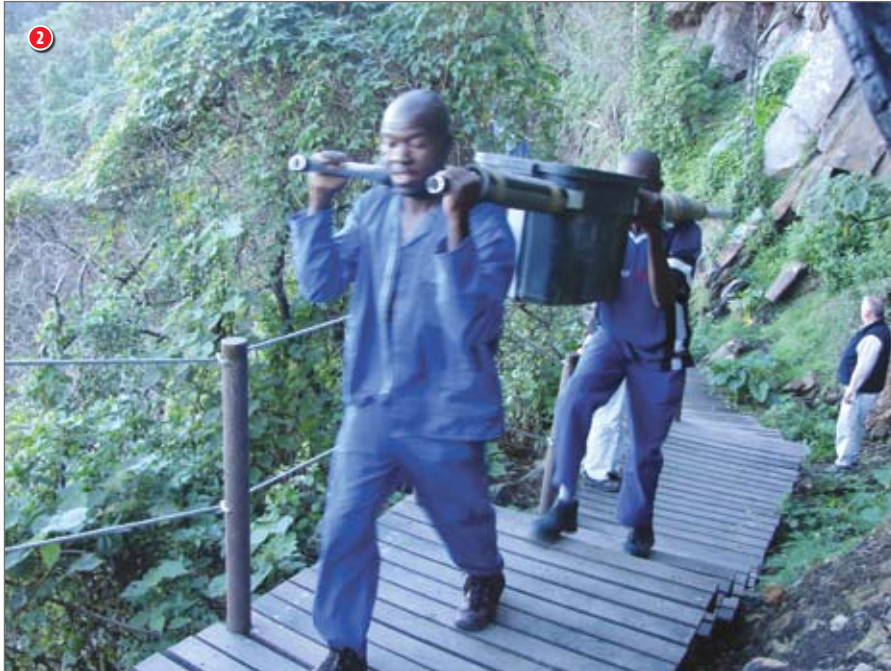
- ② All materials and support works were carried in by hand
- ③ Not the easiest site conditions – centre pier under construction

All materials and support works were carried in by hand along a 1 km winding boardwalk, which was steep in places with steps, and which was also still being used by tourists.

In order to bring in the materials, the contractor manufactured unique carrying containers, not unlike an old-style sedan chair, which could be carried by two people, safely and with health and safety criteria in mind. The heavy suspension cables were unwound from their drums and carried in by a long team of labourers in 'snake' fashion.
