# The Rehabilitation of the Armco Pipe Arch Culvert on the P14-1 at Kilometre 5.2

## FINALIST – Technical Excellence Category

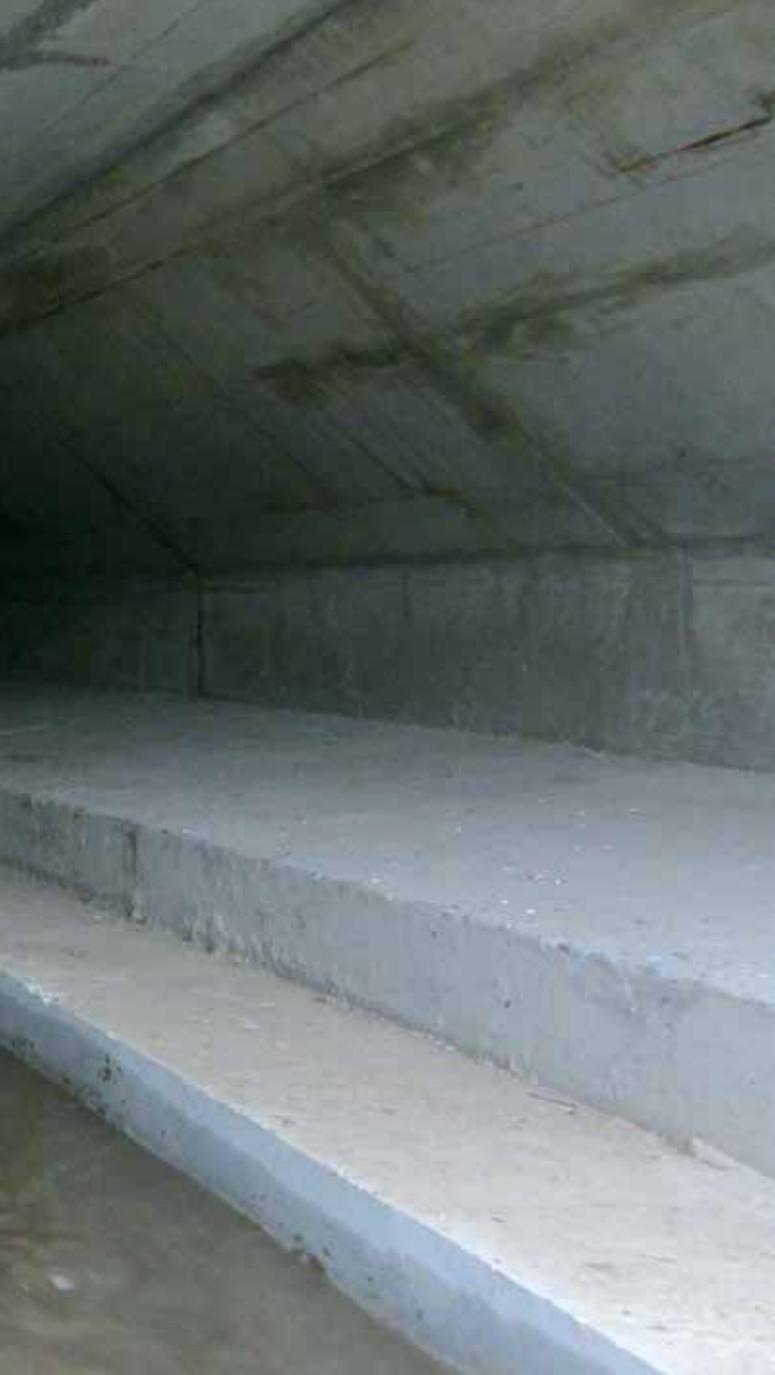
The culvert has a 6 m span, 3.6 m rise and 32 m length, with approximately 4 m of fill above. The invert was so severely corroded that it was no longer able to resist the full lateral earth pressures, and buckled in cross-sections for the full length of the culvert.

The structure's roof had also significantly distorted and was becoming noticeably bigger in the period between the monthly inspections. Structural failure was imminent, with the gradual failure being felt in the depression of the pavement caused by the continuing settlement of the fill above.

The badly deteriorated culvert

This high-risk culvert was therefore flagged for emergency rehabilitation or replacement. As a safety precaution, horizontal bracing was introduced to prevent the culvert from buckling any further. This bracing was maintained for the full duration of the design and construction periods.
